### What to look for

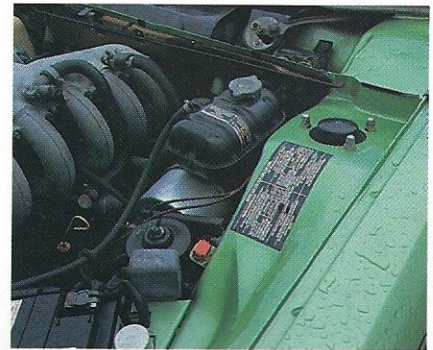
● Check where the front panel joins inner wing

As far as body panels go, the front panel generally lasts fairly well, but check the area where it joins the inner wings as the metal here is pretty thin. Bonnets can rust around the vents; these can be time consuming to repair, and good second hand bonnets are becoming increasingly rare.

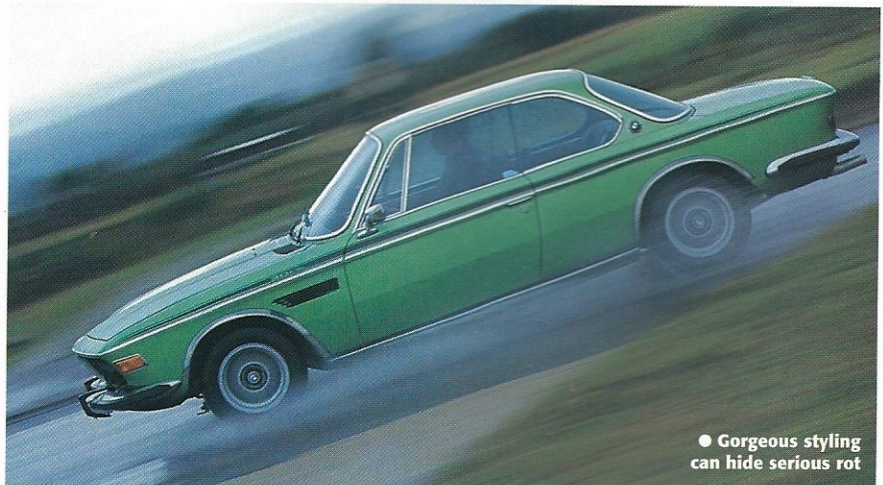
● Gorgeous styling can hide serious rot
